TECHNICAL REPORT REMR-CO-3

**CASE HISTORIES OF CORPS BREAKWATER
AND JETTY STRUCTURES**

Report 3

NORTH CENTRAL DIVISION

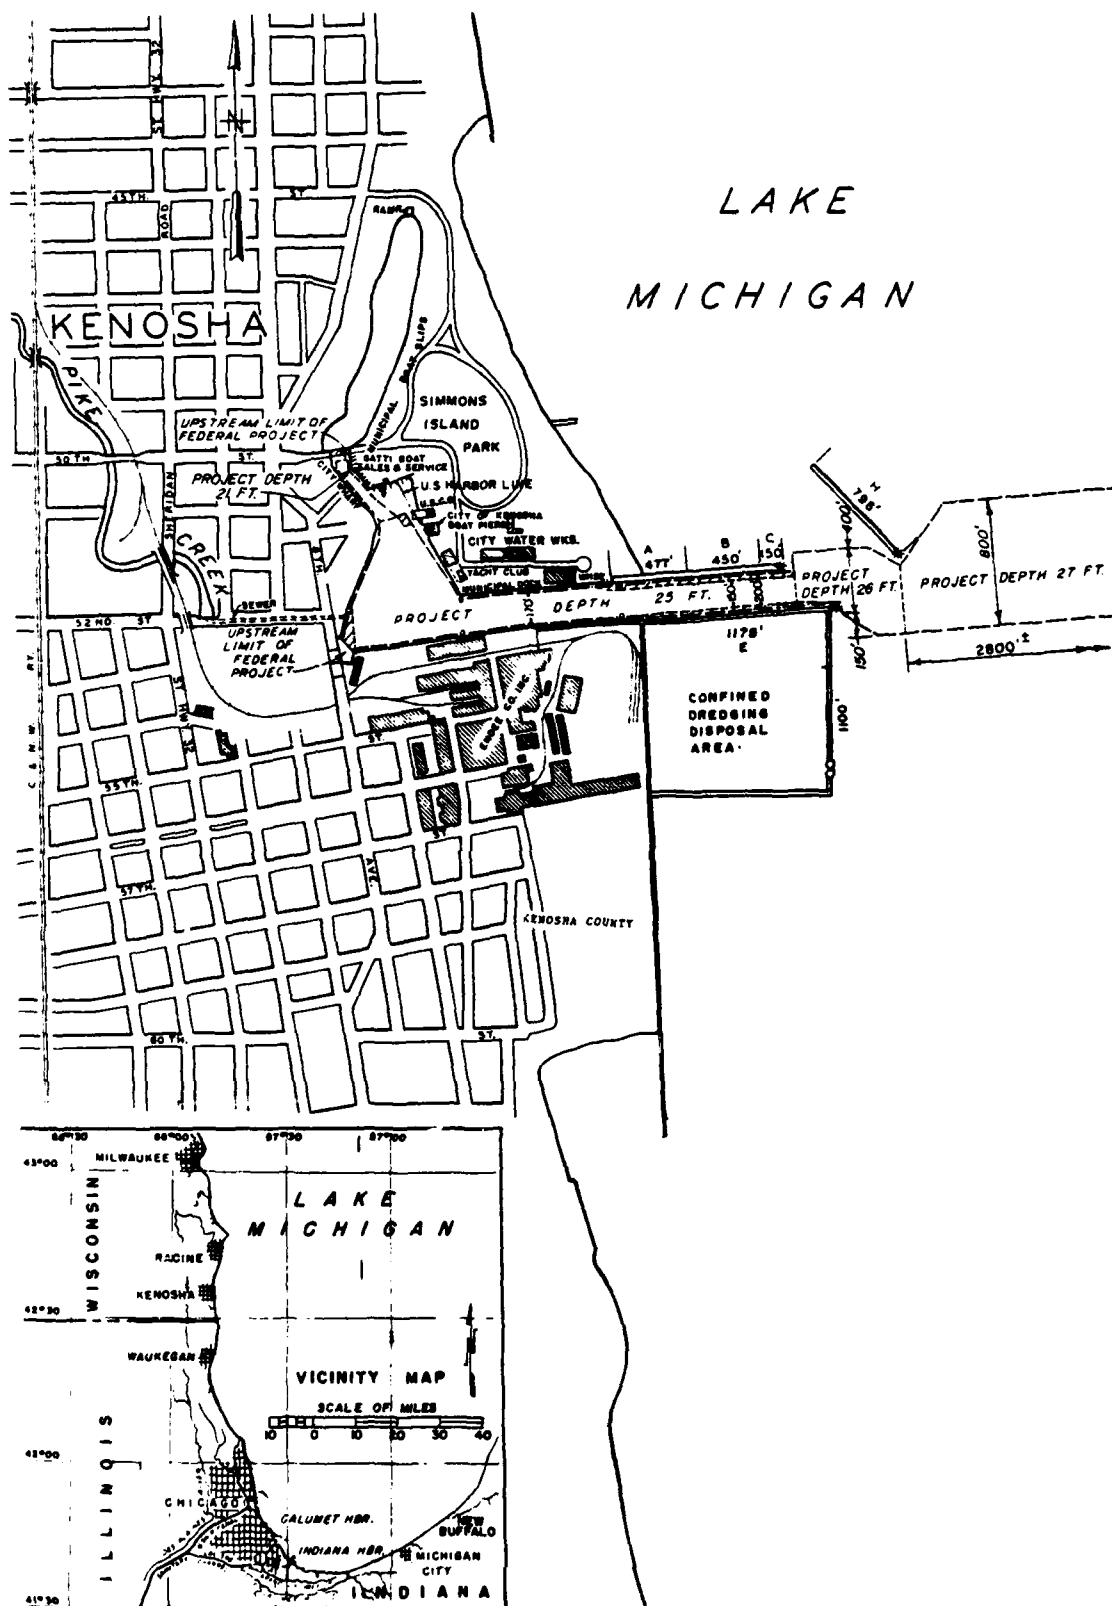
Figure 91. Kenosha Harbor, Wisconsin

1969- 1970	The north and south piers were rehabilitated during this time (Figure 92, Sections A, B, C, and E). Steel sheetpiling was driven on each side of the north pier resulting in a structure 30 ft wide. Voids were filled with stone, and a concrete cap was installed at a crest el of +8.5 ft. Riprap was installed on each side of the structure. Steel sheetpiling was installed on the lakeward side of the south pier. The void and the existing pier were filled with 50-lb stone. A parapet wall was installed on the lakeward side of the structure to an el of +10 ft lwd. (This was adjacent to a confined dredging disposal area).
1977	The detached breakwater (Figure 92, Section H) was rebuilt, and 1- to 6-ton (3-ton average) riprap stone was placed on each side of the structure to an el of +4 ft lwd. Side slopes of the riprap were 1V:1.5H.
1980	A site inspection of the structures revealed them to be generally in good condition. Spalling of concrete was noted in several areas; however, the problem was not critical at that time.

1986	The structures presently are considered to be in fair condition.

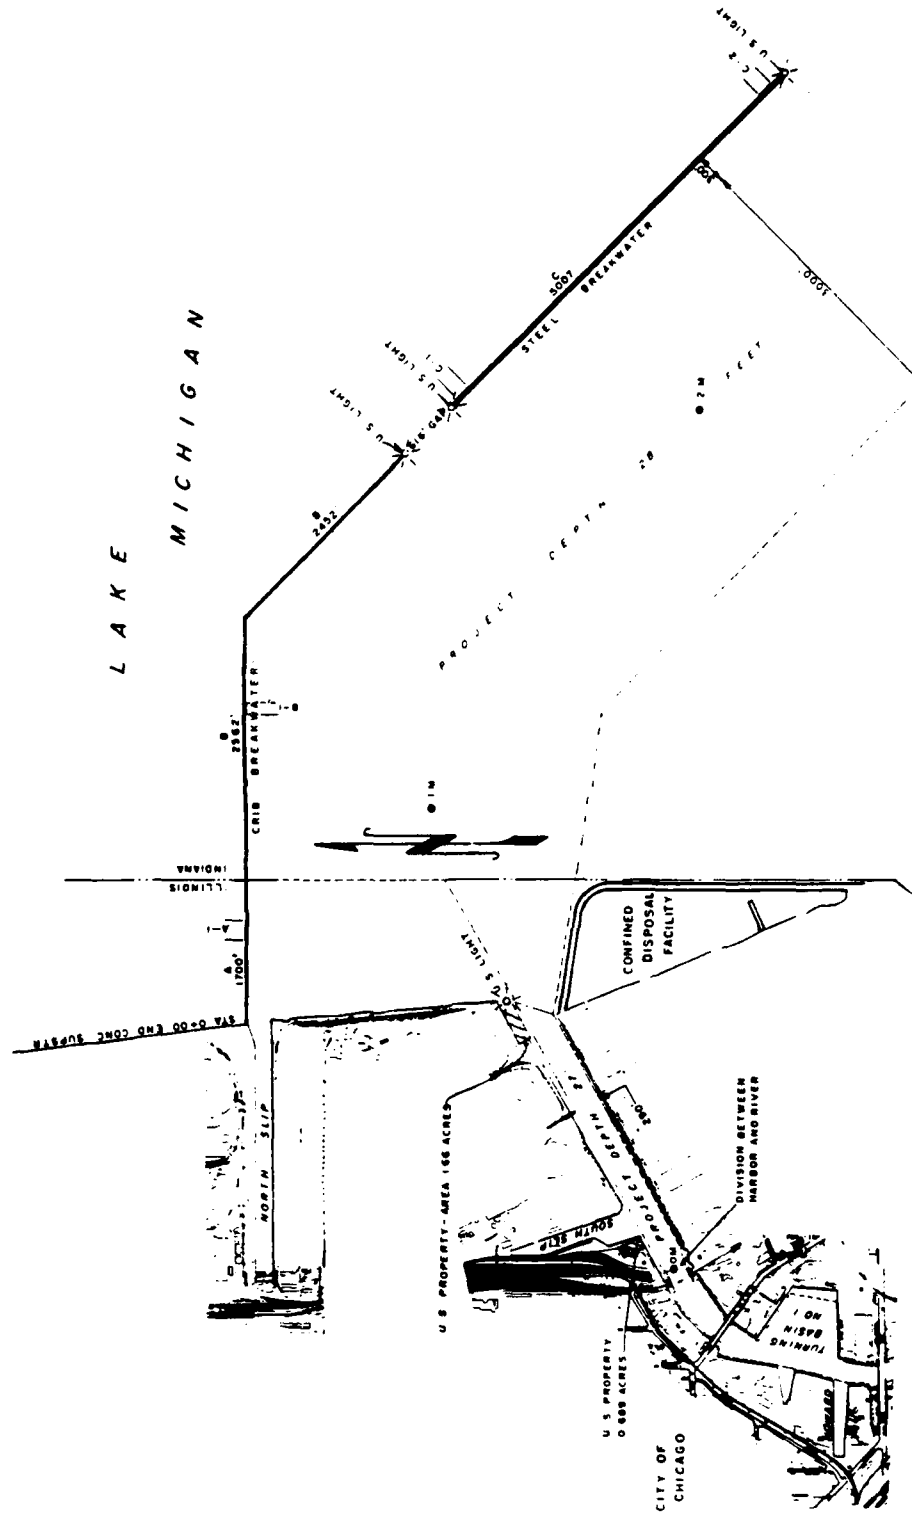
Figure 100. Calumet Harbor, Illinois and Indiana

1957	Portions of the detached breakwater (Figures 100 and 101, Sections C-1 and C-2) were repaired. Heavy riprap stone was placed on each side of the structure at the northern end (Section C-1) and on the lakeside of the breakwater on the southerly end (Section C-2).
1961- 1962	Portions of the attached timber crib breakwater (Figures 100 and 101, Sections A-1 and B-1) were repaired. Riprap protection was placed on the lakeside of the breakwater at Section A-1 and on the harbor side at Section B-1.
1984	A severe storm occurred in February with estimated wave heights of 15 ft. Two cells at the southern end of the detached breakwater failed, and the fill stone was lost under the impact of the storm waves. Stones ranging from 6 to 23 tons were placed on the ends of the damaged cells in October to stabilize them and prevent damage to adjacent cells. A total of 3,938 tons of stone was used during these repairs. During November a site inspection of the attached timber crib structure revealed damaged concrete with exposed rebar, spalling, concrete deterioration, fractured concrete, voids, and erosion of some cribs on the harbor side.

1985	A reconnaissance report for breakwater rehabilitation was published by NCC recommending conversion of the attached breakwater to a rubble-mound structure as an attempt to preserve the detached breakwater with rubble-mound berms installed on each side.

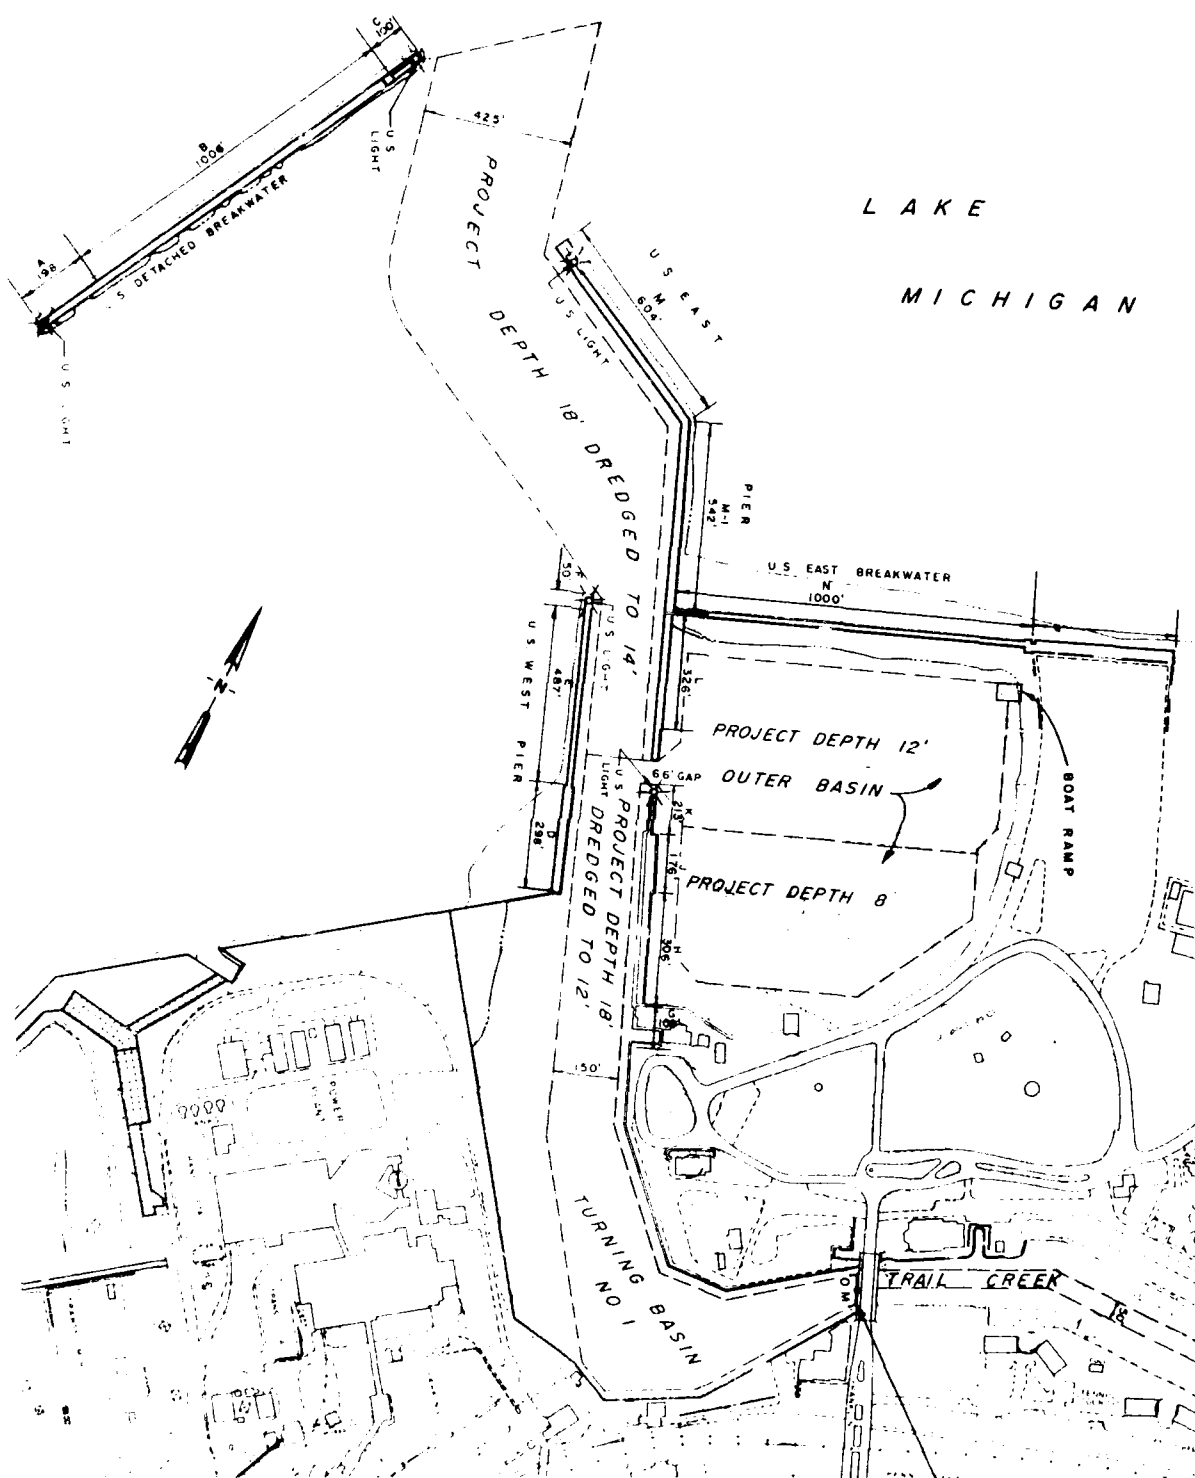
Figure 105. Michigan City Harbor, Indiana

1972	The shoreward portion of the west pier (Figure 105, Section D) and a portion of the east pier (Figure 105, Sections H and J) were rehabilitated. Steel sheetpiling was driven on each side of the existing piers, and the voids were filled with stone. The west pier (Figure 107, Section D) was capped with concrete with a crest el of +7 ft lwd and a new width of 28 ft. The east pier (Figure 106, Sections H and J) consisted of a concrete and stone cap installed at a crest el of +7.85 ft lwd. The inner portion (Section H) was 34 ft in width and remaining portion (Section J) was built 38 ft wide.
1978	The concrete cap on the shoreward end of the detached breakwater (Figures 105 and 107, Section A) was rebuilt.
1979	An inspection of the structures indicated that the east breakwater was in fair condition and the other structures generally were in good condition. Riprap on the lakeside of the detached breakwater was low in areas, and the concrete cap on the east pier had deteriorated in areas. Subsequent maintenance repairs have been performed.

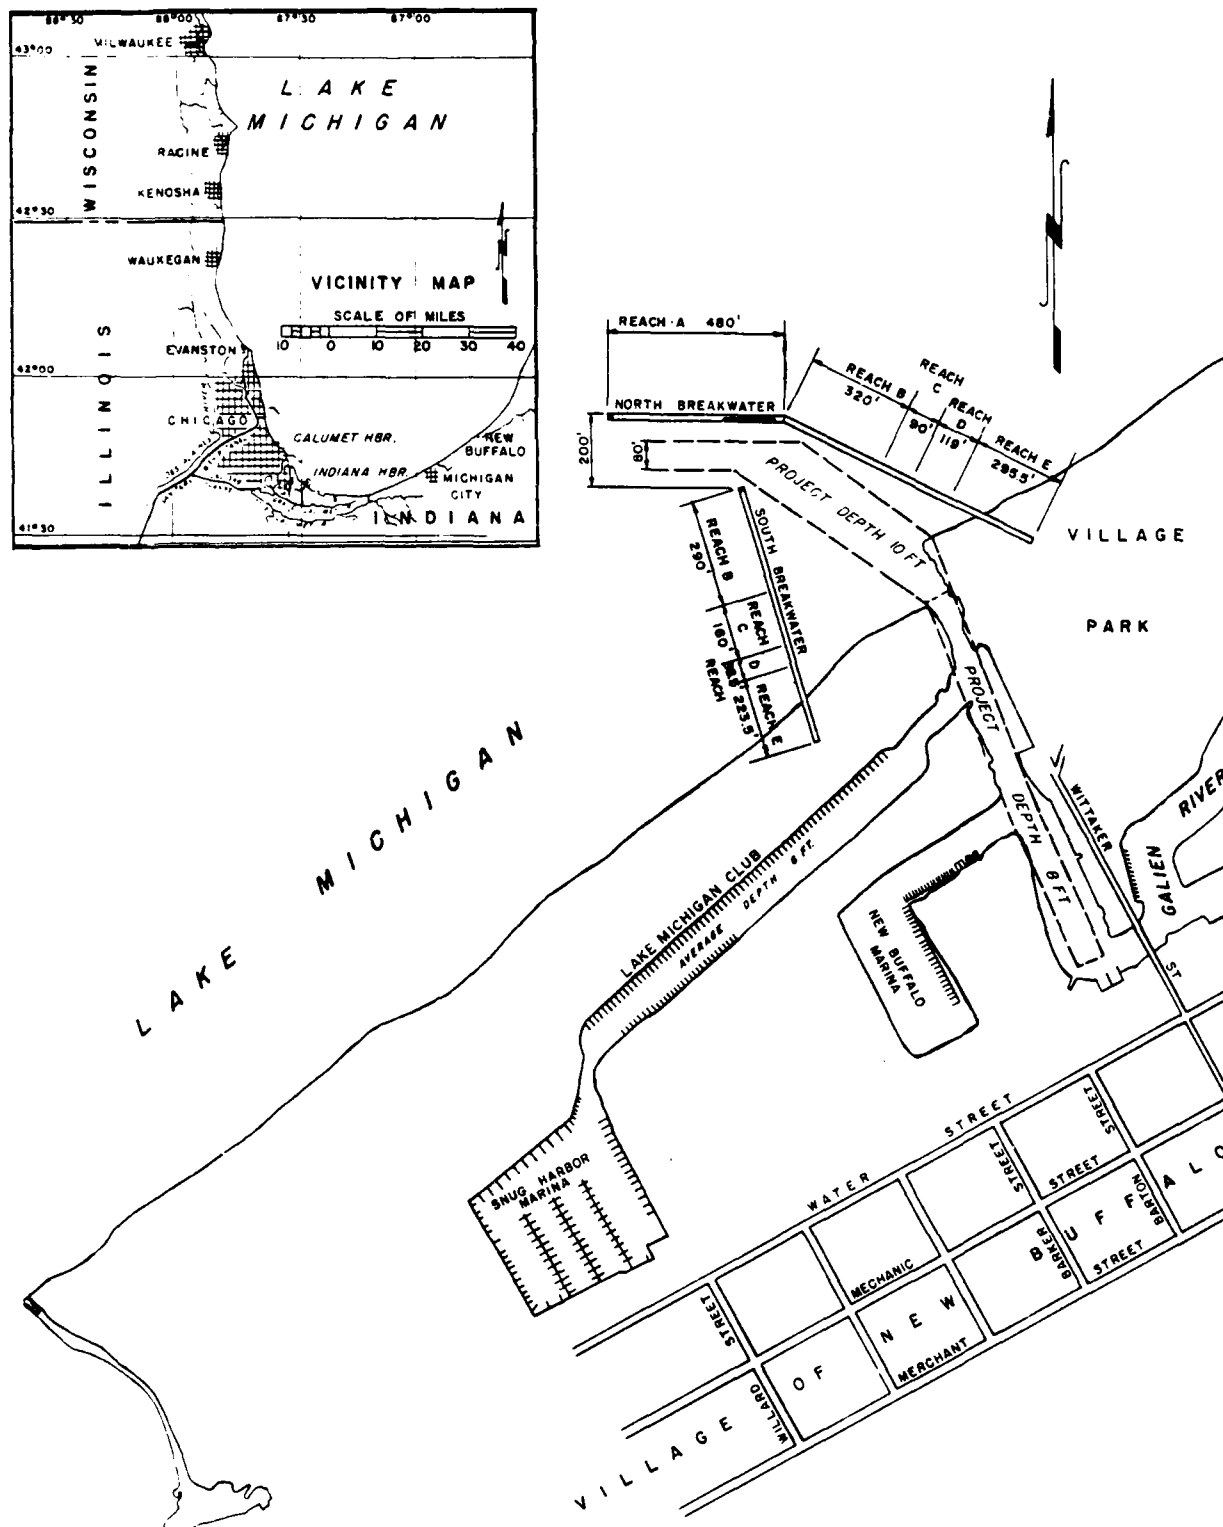
Figure 108. New Buffalo Harbor, Michigan

1980	<p>An inspection of the structures at the site indicated that voids existed in the outer reach (Reach A) of the north breakwater and minor settlement had occurred, particularly around the head of the structure adjacent to the navigation lights. The remaining portion of the rubble-mound north breakwater also consisted of many voids with some stones deteriorating (cracking or crumbling into smaller pieces). The outer portion of the south breakwater (Reaches B and C), although in better condition than the north structure, also had experienced some settlement and contained some gaps where waves washing through the structure was noted. The inner portion of the breakwaters was in good condition.</p>
1983	<p>Stone was placed in the voids of the outer portions of each breakwater (Reaches A and B, north breakwater, and Reach B, south breakwater, Figure 108). A site inspection in the latter part of the year revealed that some of the smaller stone (used to fit the voids) had washed out. Voids in the trunk sections of the breakwater (Reaches C and D, north structure, and Reach C, south structure) still existed along with settlement of 1 to 2 ft in some areas.</p>

1986	<p>The structures are presently considered in fair condition. Maintenance repairs of the breakwater have been recommended but not yet implemented.</p>

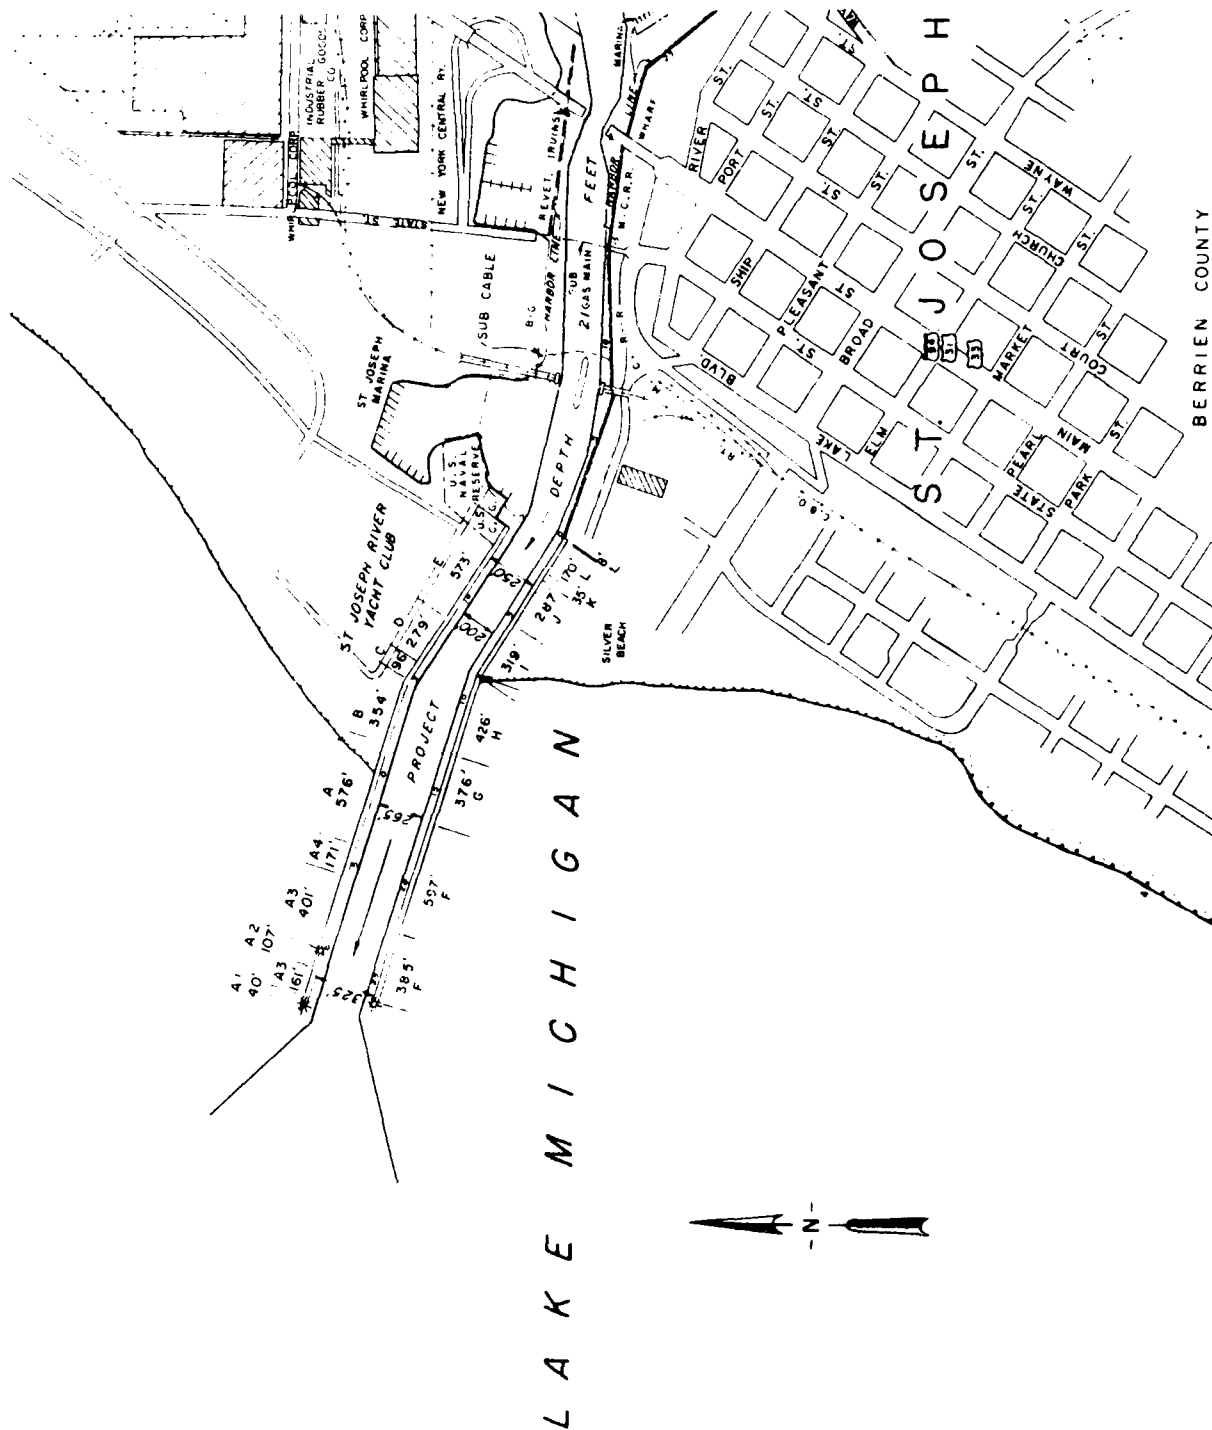
Figure 110. Saint Joseph Harbor, Michigan

1982	Stone fill in portions of the north pier (Figure 110, Sections A1, A, and B) was replenished, and new concrete caps were installed in these areas.
1985	An inspection of the structures revealed that fill stone was 3 to 6 ft low in areas of the north pier and that cracking of the superstructure was prevalent in places. It was also noted that fill stone in the south pier was settling which was also causing cracking of the concrete superstructure. Maintenance repair of the structures has been recommended but not yet performed. The piers are considered to be in fair condition.

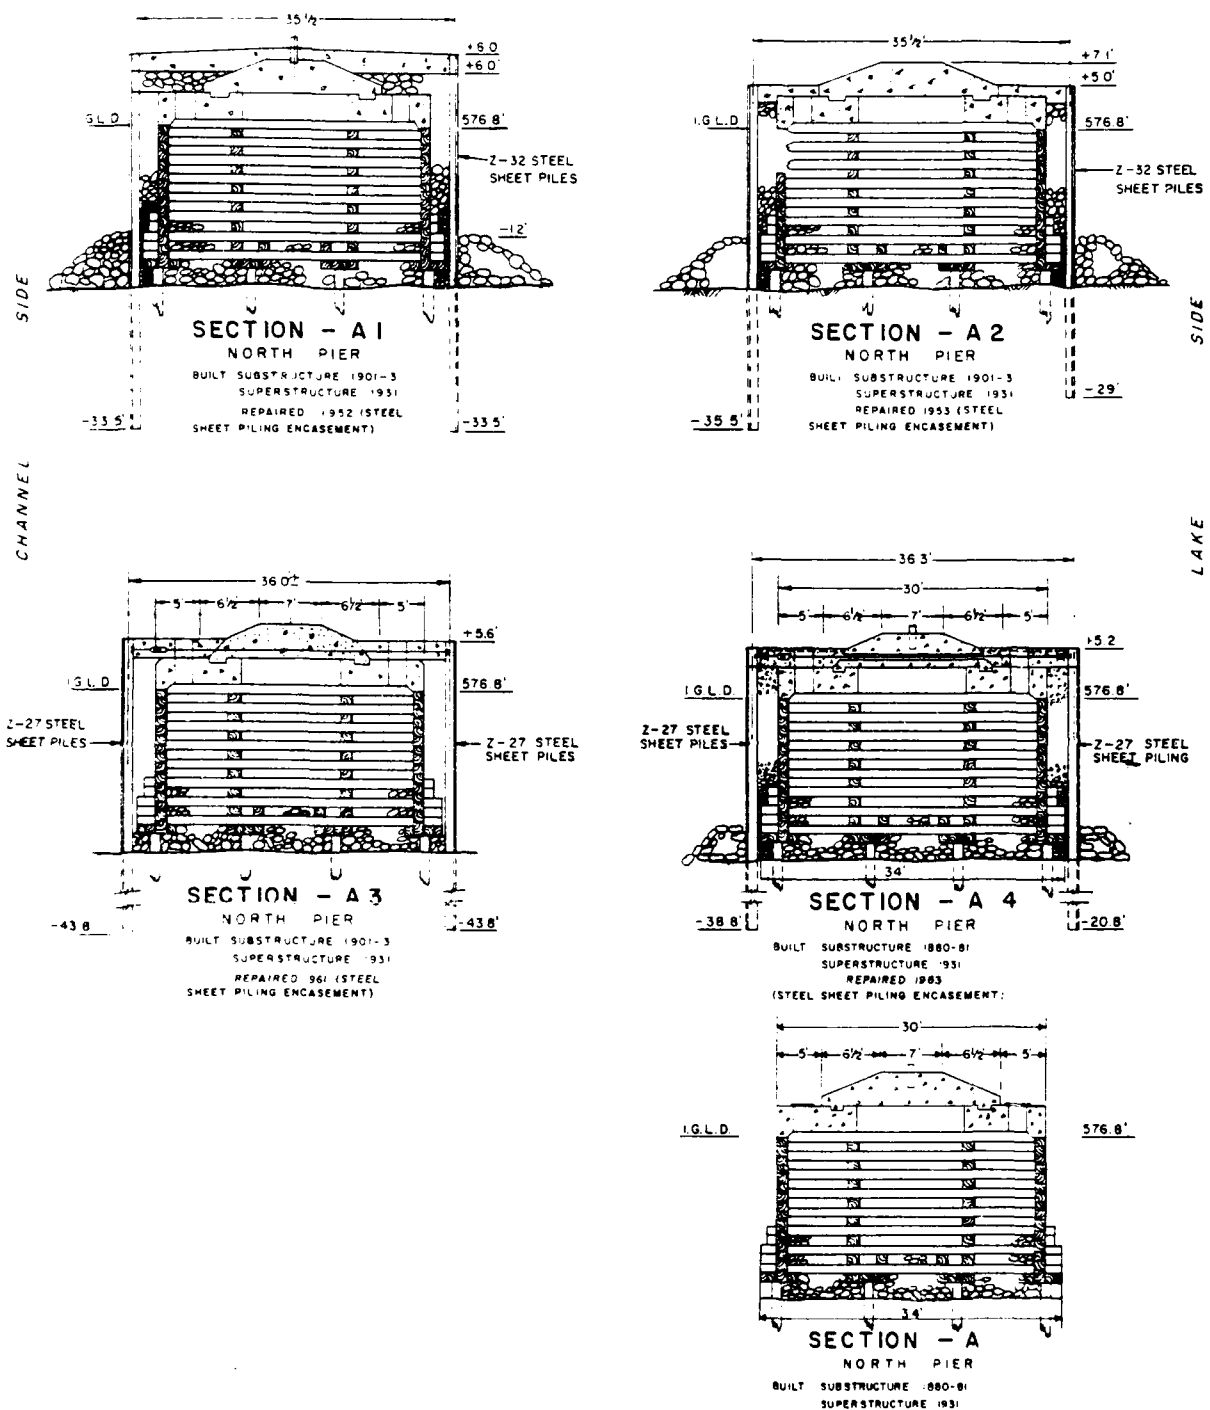
Figure 111. Typical north pier cross sections,
Saint Joseph Harbor, Michigan

1952- 1953	Portions of the north pier (Figure 110, Sections A1 and A2) were repaired by enclosing the structure in a steel sheetpiling encasement (Figure 111, Sections A1 and A2). Voids were filled with concrete, and the pier was recapped with concrete. The outer portion (Section A1) had a crest el of +8.0 ft lwd and was 35.5 ft wide, while the other portion (Section A2) was +7.1 ft lwd with a width of 35.5 ft. Riprap toe protection was also installed on each side of the piers adjacent to the new sheet-pile walls.
1961	Additional portions of the north pier were repaired (Figure 110, Section A4, C, D, and E) by using steel sheetpiling. The shoreward portions of the pier were repaired by installing sheetpiling on the channel sides of the existing structures (Figure 112, Sections C, D, and E) and backfilling the voids with stone prior to capping the area with concrete. The el of this portion of the pier was +7.0 ft lwd. The remaining portion of the pier was repaired by enclosing the structure in a steel sheet-pile encasement (Figure 111, Section A3). Voids were filled, and the structure was capped with concrete to an el of about +7.6 ft lwd. The pier width was approximately 36 ft.

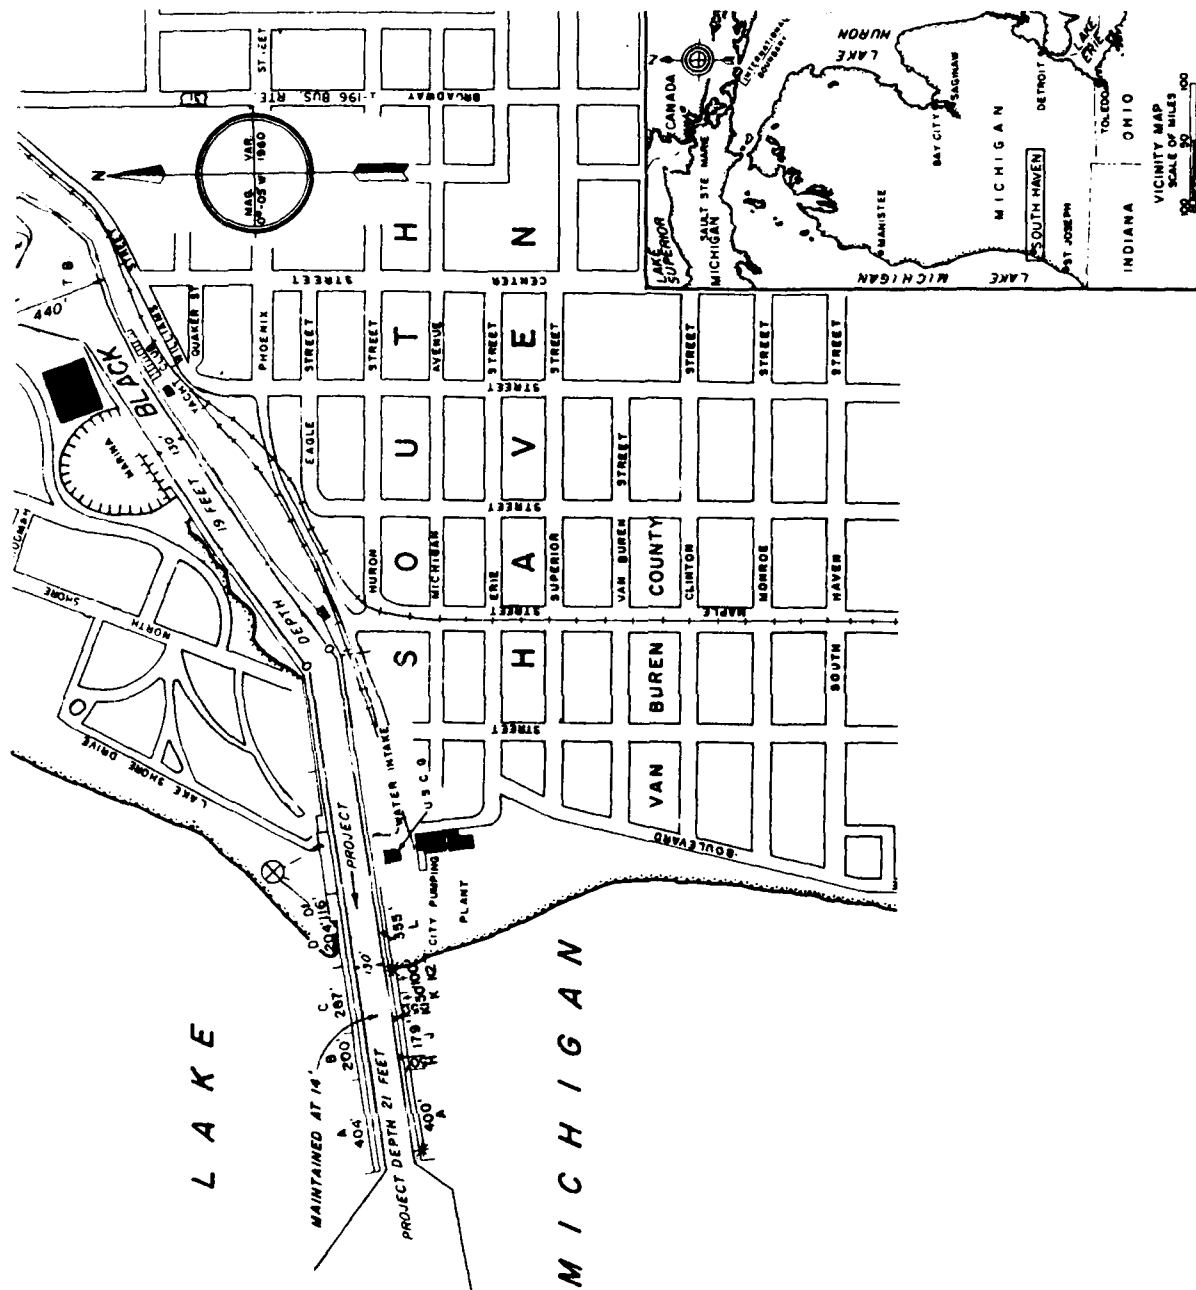
Figure 114. South Haven Harbor, Michigan

1981	Riprap ranging from 1 to 6 tons was placed along the lakeside face of the north pier (Figure 114, Section A). Approximately 1,788 tons of stone was used that extended from the head of the pier 600 ft shoreward. Also, 38 tons of 2- to 4-in. stone was placed under the caps to replenish fill stone.
1982	Approximately 1,029 tons of riprap was placed along the north pier (Figure 114, Sections A and B) and 2,054 tons along the south pier (Figure 114, Section A). Three- to sixteen-ton stone was used for the purpose. Additionally, 40 tons of 1- to 3-ft stone was placed under the caps of the south pier to replenish fill stone.
1983	About 600 tons of 6- to 12-ton riprap was placed along the lakeside of the north pier shoreward of the riprap placement of 1981 and 1982.
1985	An inspection of the structures revealed that the north pier was in good condition. The lakeward end of the south pier (Figure 114, Section A) appeared stable and in fair condition. Separation, settlement, and cracking of the superstructure was noted, and maintenance repairs have been recommended. The remaining portions of the south pier were in good to excellent condition. An aerial view of the South Haven Harbor piers is shown in Figure 118.

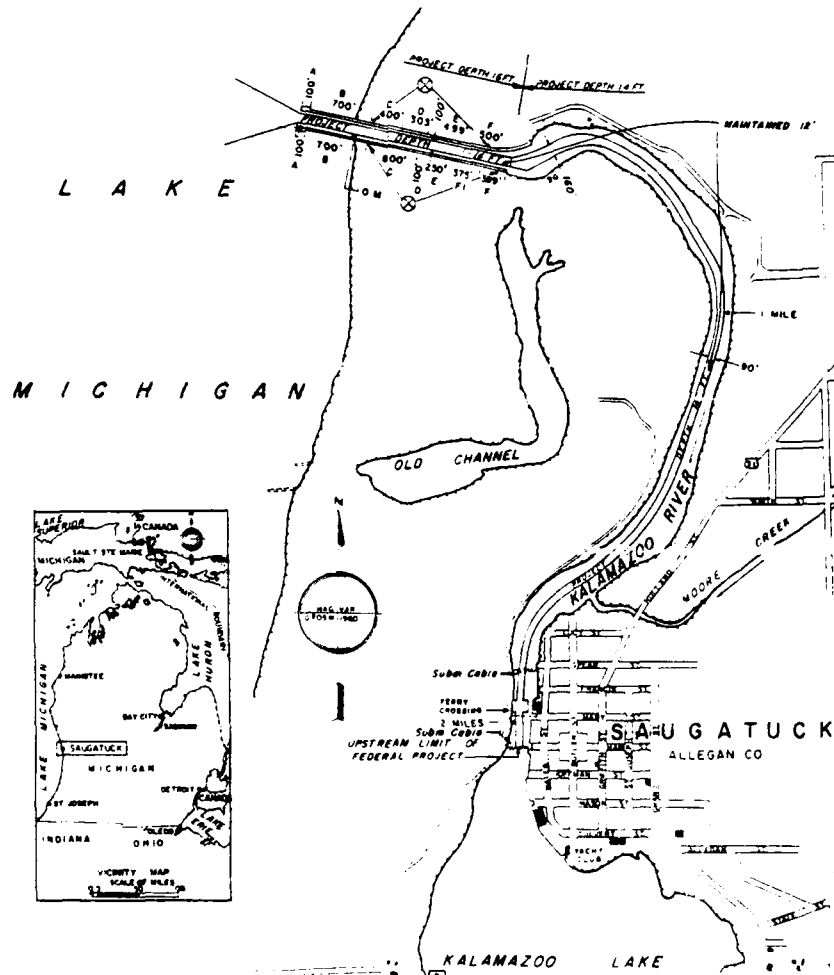
Figure 119. Saugatuck Harbor, Michigan

Date(s)	Construction and Rehabilitation History
	Section D of the south pier. About 470 tons of the 50- to 300-lb ballast stone was placed into or along the north revetment.
1985	An inspection of the structures indicated the north pier to be in fair to poor condition. Fill stone had again settled, and the superstructure was still in poor condition because of cracking, settlement, tilting, etc. The south pierhead was in a poor to near failed condition (Figure 119, Section A), while the remaining portion of the pier is in a condition of fair to poor similar to the north pier. The only exception is Section F1 which is still considered to be in good condition.
1986	A major rehabilitation study for the piers is under way. Consideration is being given to using rubble-mound structures as opposed to vertical steel sheetpiling. An aerial photo of the Saugatuck Harbor Piers is shown in Figure 121.

1982	Approximately 300 tons of 6- to 12-in. fill stone was used to replenish the stone fill under the superstructure of the south pier. Additionally, about 500 tons of 50- to 300-lb ballast fill stone was placed into Section C (Figure 119) and along the lakeside of

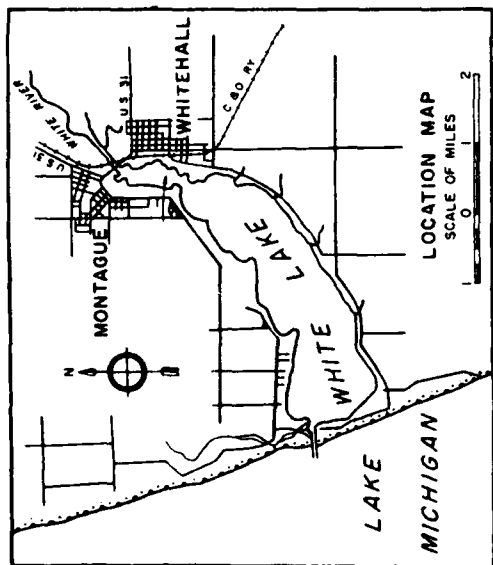
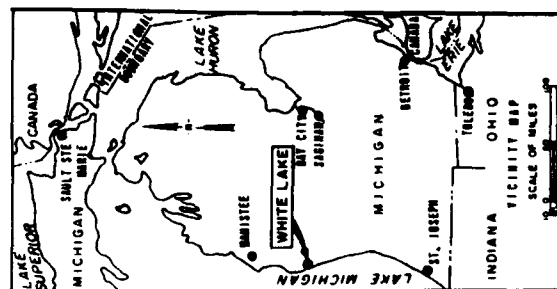
Figure 134. White Lake Harbor, Michigan

1985	An inspection of the structures indicated that the substructures of both piers are deteriorating, resulting in superstructure settlement and cracking, considerable misalignment and tilt, and loss of fill stone. Both structures are considered to be in poor condition. Reconstruction and/or rehabilitation has been recommended within the next 2 to 3 years.

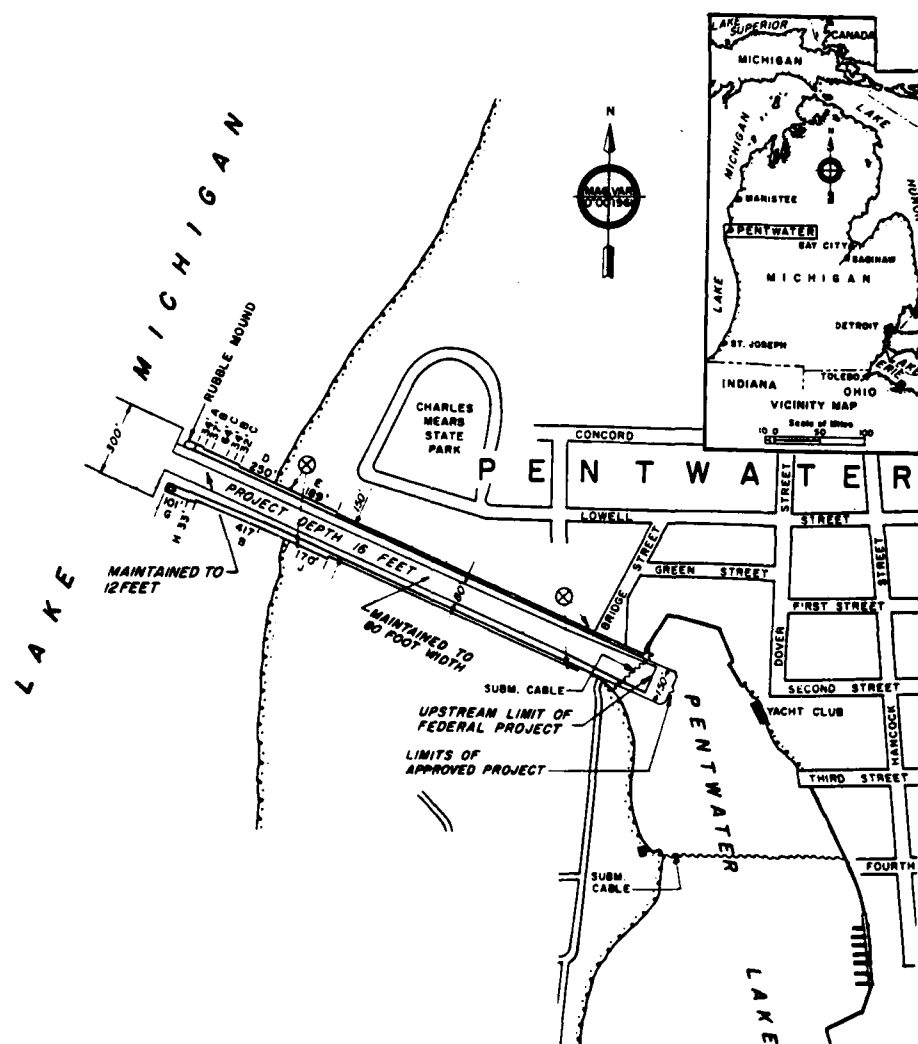
Figure 136. Pentwater Harbor, Michigan

Date(s)	Construction and Rehabilitation History
	replenishment and concrete capping were completed to Sections A, B, C, D, and E of the north pier and Section G of the south pier (Figure 136).
1985	A site inspection of the structures indicated that the rubble-mound extension of the north pier (Figure 136) has settled up to 1 ft throughout. The remaining portions of the north pier (Sections A, B, C, D, and E) and the south pier (Sections G, H, B, and J) are bulging, tilting, leaning, cracked and misaligned. These factors, along with loss of fill stone, indicate substructure deterioration. The structures are considered in poor condition; however, major rehabilitation has been recommended and is scheduled for 1987. An aerial view of the Pentwater Harbor piers is shown in Figure 138.

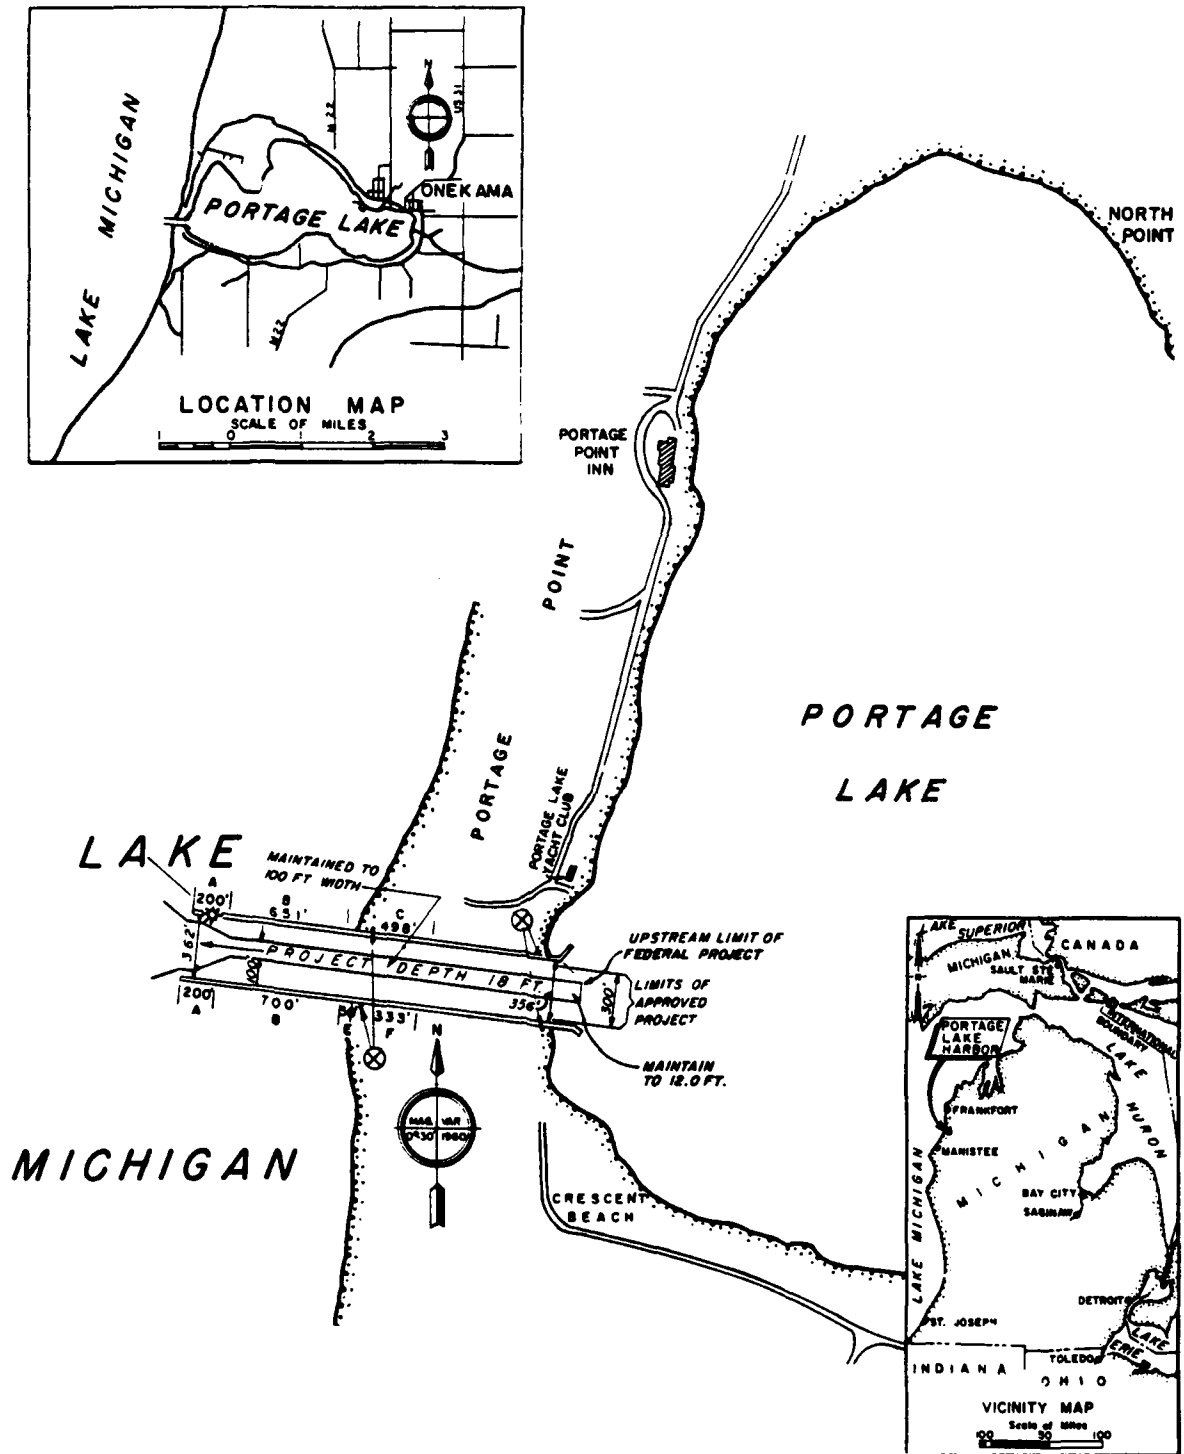
Figure 149. Portage Lake Harbor, Michigan

1980- 1981	Riprap stone was placed around the heads of the north and south piers (Figure 149, Section A) during this period, and stone fill was replenished at various areas along both piers. After replenishment, the concrete caps were repaired.
1985	An inspection of the site indicated the piers were, in general, in fair condition. Settlement and cracking of the superstructure and fill stone loss indicate some substructure deterioration. Replenishment with large fill stone has been recommended along with additional riprap installation. An aerial view of Portage Lake Harbor piers is shown in Figure 151.

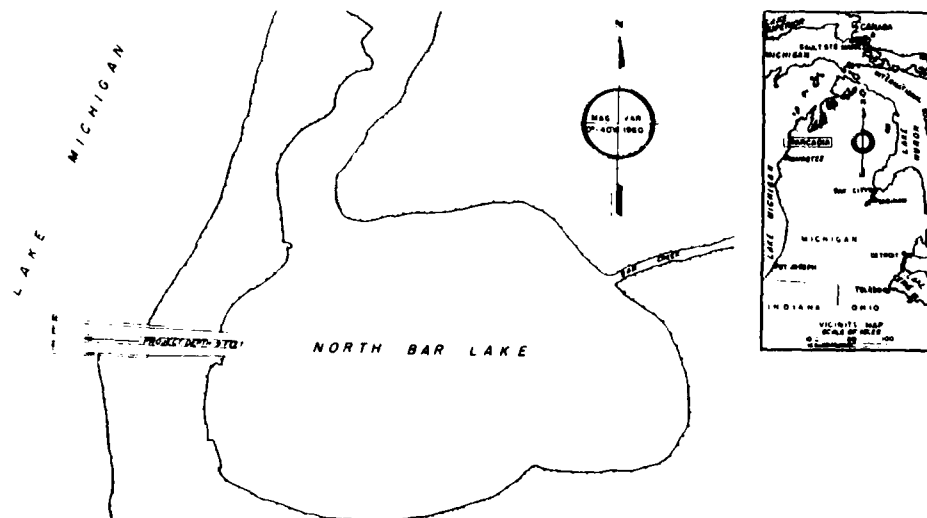
Figure 152. Arcadia Harbor, Michigan

1985	An inspection of the site indicated settled and/or washed out stone in numerous areas of the north pier. Water is washing through the voids of the structure, and three areas are nearly breached. The steel sheet-pile cell at the head of the south pier is completely broken out, and most of the grout cap along the entire length of the pier is missing with stone being washed out. The condition of the piers is very poor, and immediate reconstruction/rehabilitation has been recommended.

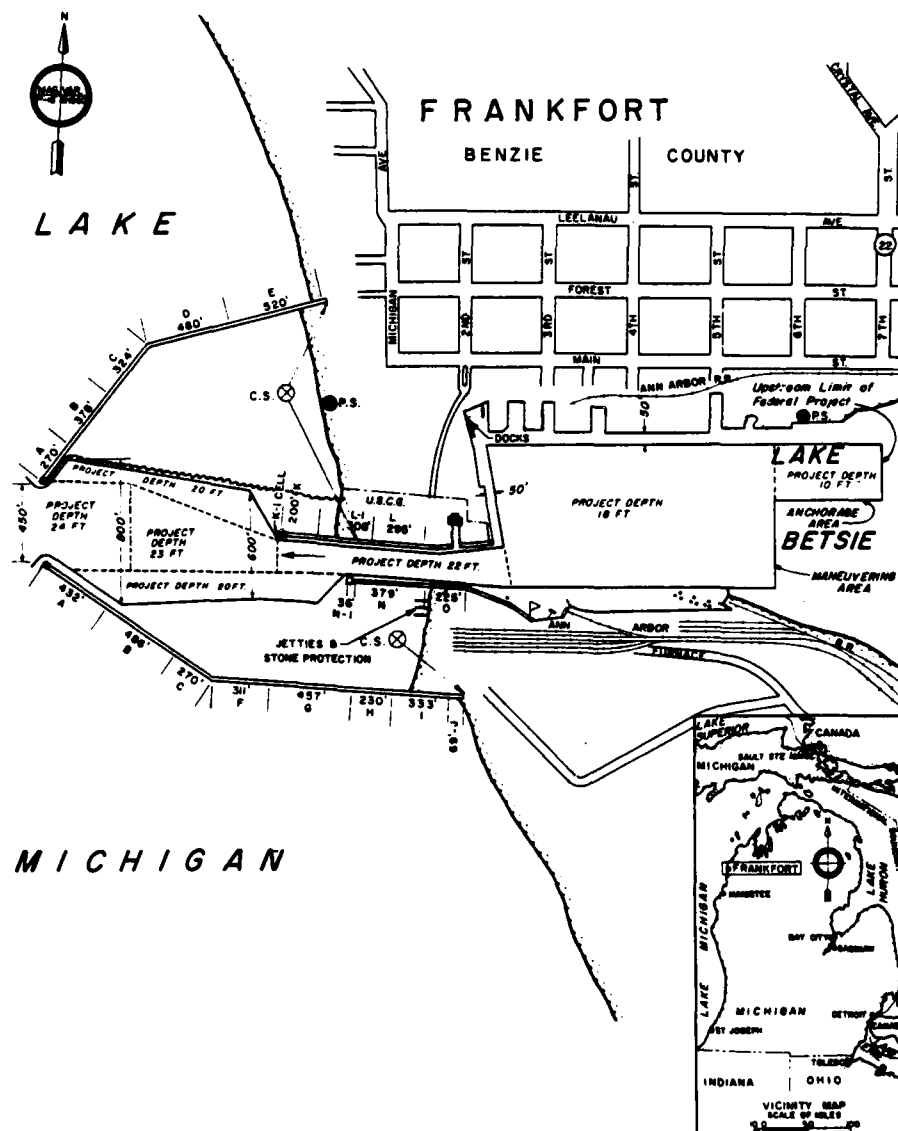
Figure 153. Frankfort Harbor, Michigan

Date(s)	Construction and Rehabilitation History
1984	Riprap stone was placed along the lakeward end of the south breakwater (Figure 153, Section A).
1985	An inspection of the structures indicated that the breakwaters were, generally, in fair condition. Their superstructures revealed cracks, settlement, and misalignment in areas, which indicate some substructure deterioration. Riprap was also needed in areas. The piers were considered in good condition during the inspection. An aerial view of the Frankfort Harbor structure is shown in Figure 157.

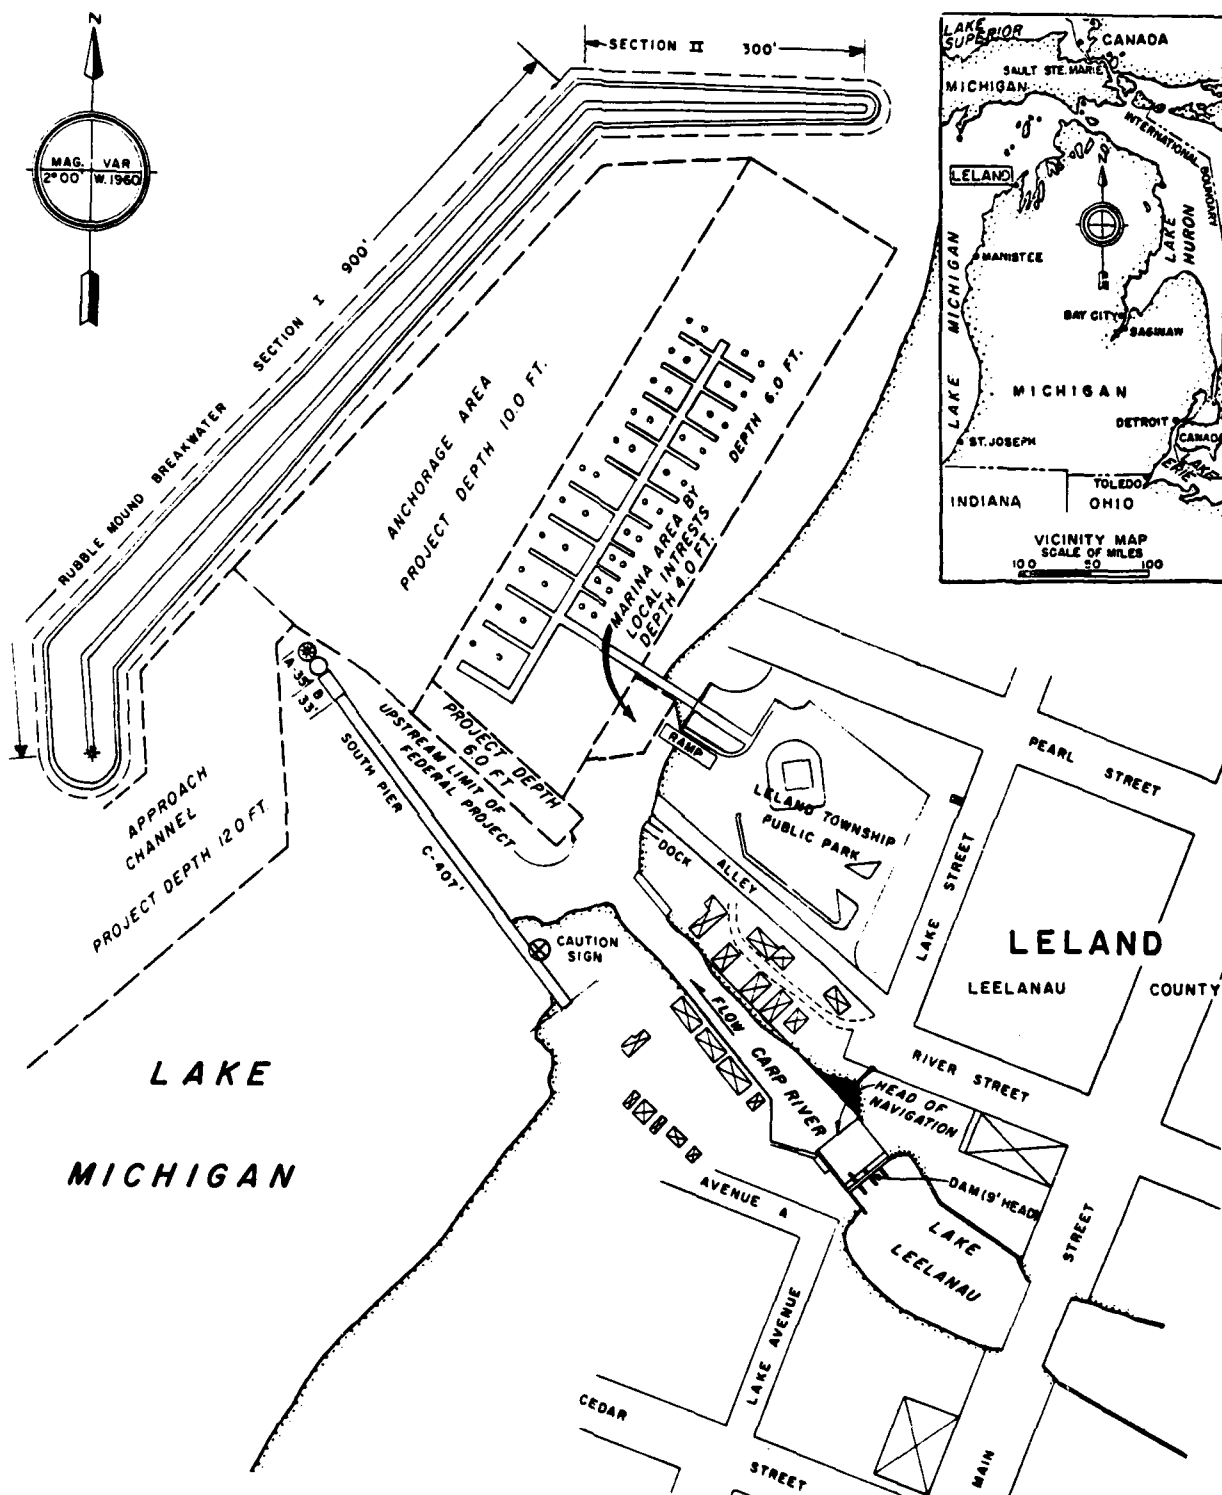
Figure 158. Leland Harbor, Michigan

1983	A site inspection of the harbor structures revealed them to be in fair to good condition. Settlement of cover stone and a portion of the north shore arm of the breakwater (Figure 158, Section II) was observed and has subsequently been repaired by the placement of additional stone. Stone settlement of portions of the entire south pier were observed and scheduled for replenishment.
1985	The structures are currently considered to be in good condition.
